CITY OF BALTIMORE WET W SMOKE AND DYED W	Page 1 of 5		
Sewershed: Low Level Subsewershed: 41	Company: REI/DRAYCO	Date: 08/05/2008	
Test Type: Smoke	Ground Condition: Dry: X Damp: _ Wet: _	Supervisor: E.R. Crew: 04	
Manhole ID: S19I1_022MH	Test ID: 1029-514	Notifications Made:X_ Residents, Fire, 311

CITY OF BALTIMORE SMOKE TESTING OBSERVATION SUMMARY LOW LEVEL SEWERSHED

BALTIMORE CITY PROJECT 1029 REI/DRAYCO

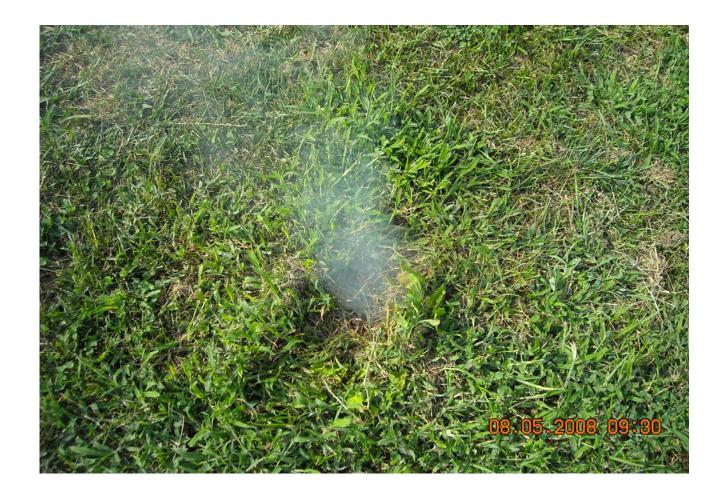
Photograph No: OB01-01 Filename: 1029-514_OB01-01.jpg

2534 SOUTHDENE AVE.

Source Type: 02 Service Line Location: 07 Yard - Front

Sector: 02 Private Severity: 03 Moderate Drainage Area: 5

Comments: SMOKE EMINATING FROM BELOW GRADE HOLE IN GROUND IN FRONT YARD.

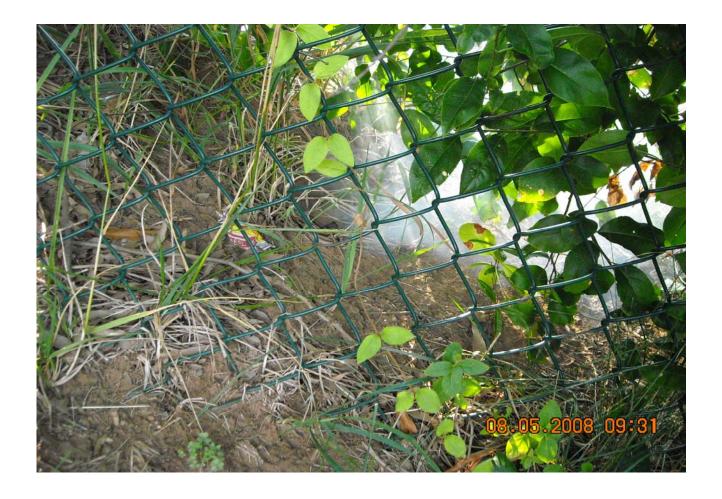
Photograph No: OB02-01 Filename: 1029-514_OB02-01.jpg

2543 SOUTHDENE AVE.

Source Type: 02 Service Line Location: 07 Yard - Front

Sector: 02 Private Severity: 03 Moderate Drainage Area: 6

Comments: SMOKE EMINATING FROM BELOW GRADE HOLE IN GROUND IN FRONT YARD.

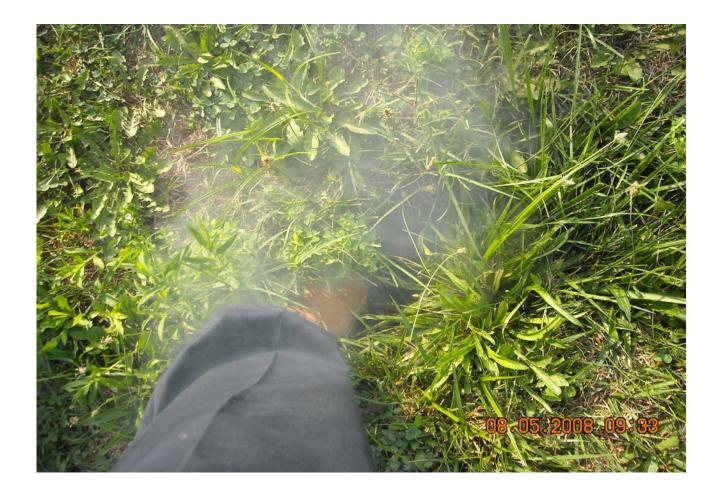
Photograph No: OB03-01 Filename: 1029-514_OB03-01.jpg

2553 SOUTHDENE AVE.

Source Type: 02 Service Line Location: 07 Yard - Front

Sector: 02 Private Severity: 03 Moderate Drainage Area: 6

Comments: SMOKE EMINATING FROM BELOW GRADE HOLE IN GROUND IN FRONT YARD.
